Re: Asbestos Consulting Services Report
Brewster Building A-Wing
East 10th Street
Greenville, North Carolina 27858
Terracon Project No. 70217599

ASBESTOS CONSULTING SERVICES REPORT

**Brewster Building A_Wing
East 10th Street
Greenville, North Carolina 27858**

November 4, 2021
Terracon Project No. 70217599

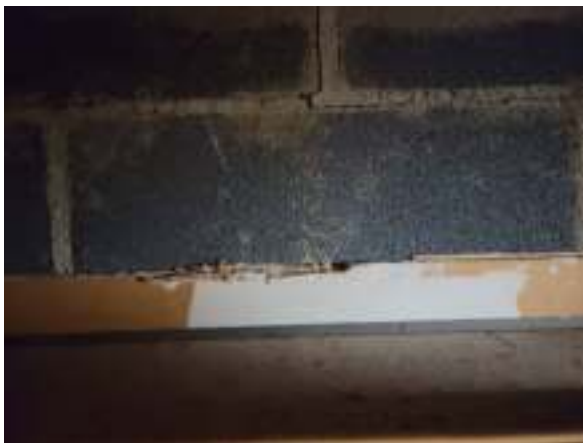
Photo #5 OSHA-regulated (<1% asbestos-containing) drywall and joint compound (HA #1)

This asbestos survey was limited to readily accessible materials in the interior of the A-Wing of the Brewster Building. Future renovations may require additional testing. Terracon recommends the identified and less than 1% asbestos ACM be managed in place.

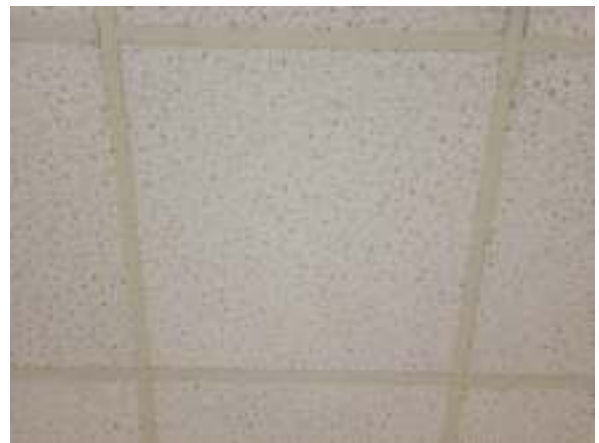
Photo #6 Non-asbestos containing 2' x 2' white ceiling tile with dots and pits (HA #2)

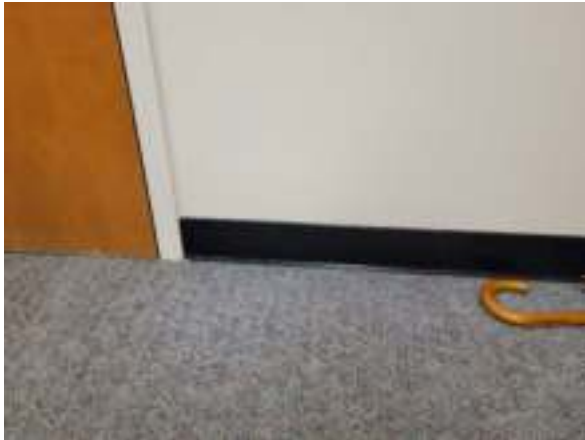
Photo #7 Non-asbestos containing 4" black covebase and mastic (HA #3)

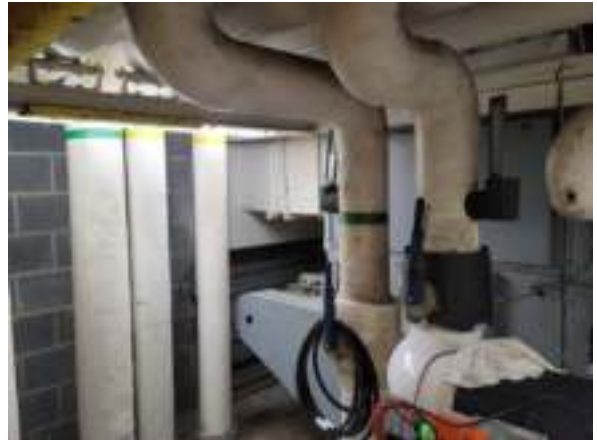
Photo #8 Non-asbestos containing white canvas wrap on 6"-8" pipes with asbestos-containing black mastic (HA #4)

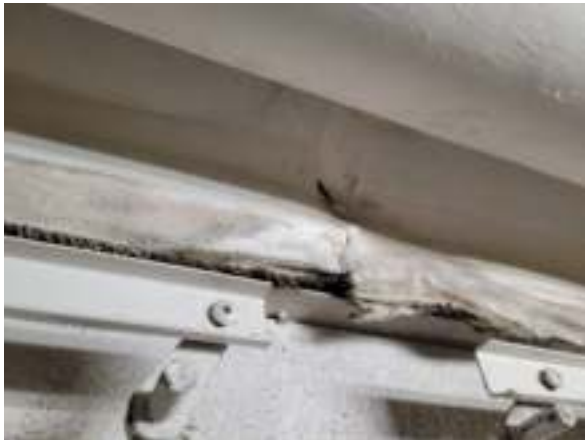
Photo #9 Non-asbestos containing white canvas wrap on HVAC duct (HA #5)

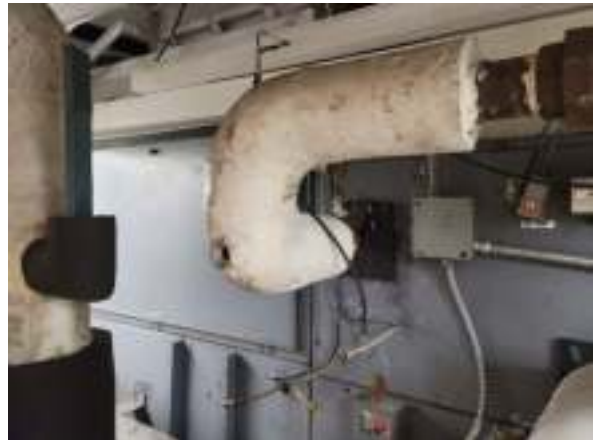
Photo #10 OSHA-regulated (<1% asbestos-containing) hard TSI elbows/joints with non-asbestos containing canvas wrap 6"-8" (HA #6)

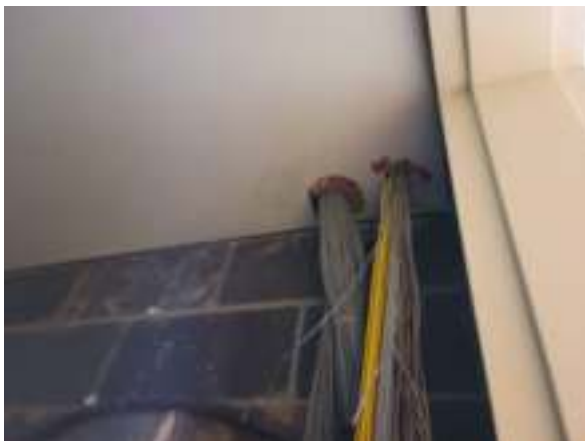
Photo #11 Non-asbestos containing red fire caulk (HA #7)

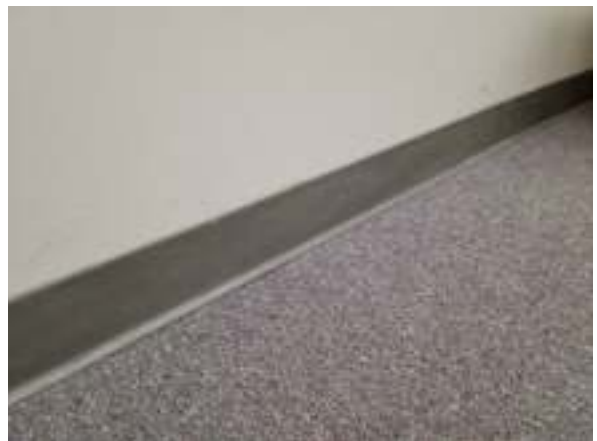
Photo #12 Non-asbestos containing 4" gray covebase and mastic (HA #8)

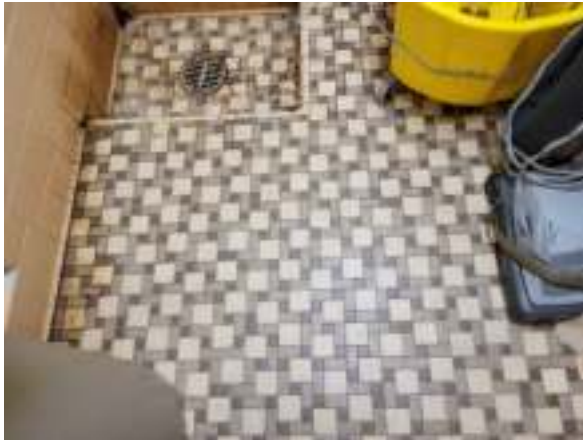
Photo #13 Non-asbestos containing ceramic floor tile grout and mortar (HA #9)

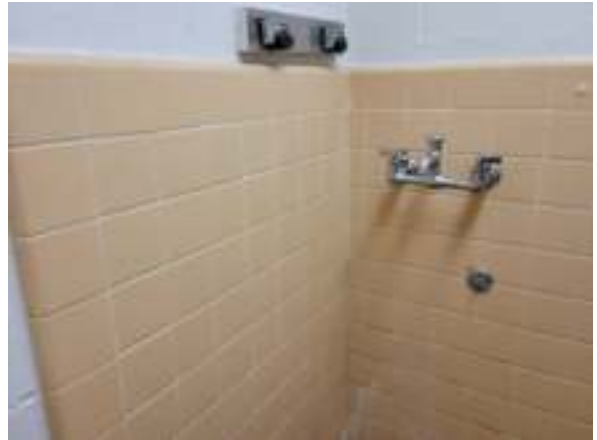
Photo #14 Non-asbestos containing ceramic wall tile grout and mortar (HA #10)

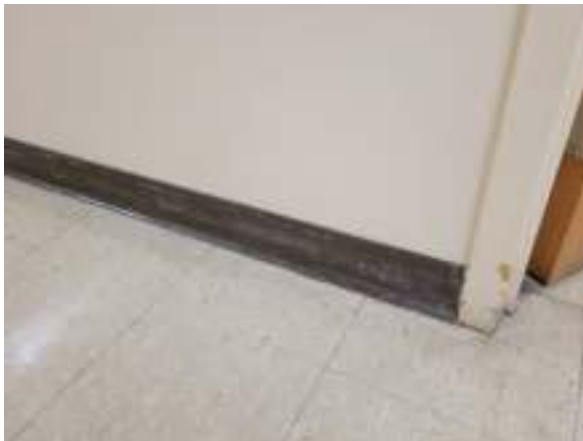
Photo #15 Non-asbestos containing 4" dark brown covebase and mastic (HA #11)

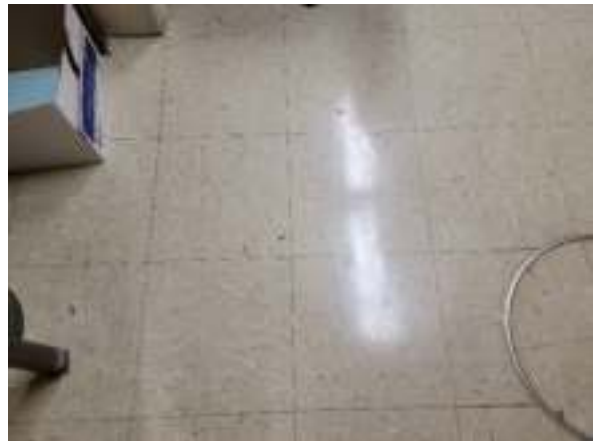
Photo #16 Asbestos-containing 12" x 12" gray with brown and black specks floor tile and mastic (HA #12)

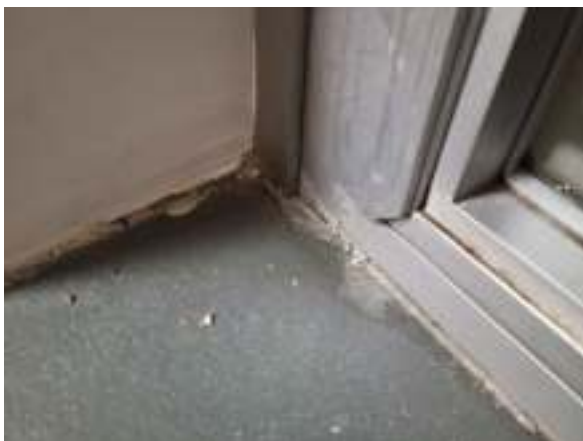
Photo #17 Non-asbestos containing gray interior window sealant (HA #13)

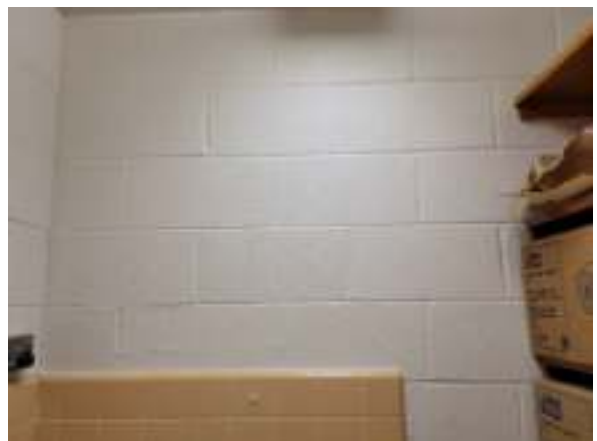
Photo #18 Non-asbestos containing CMU surface block filler (HA #14)

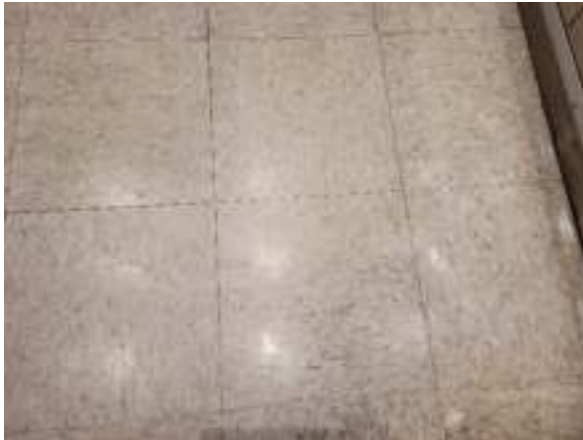
Photo #21 Non-asbestos containing 12" x 12" tri-gray floor tile and mastic (HA #15)

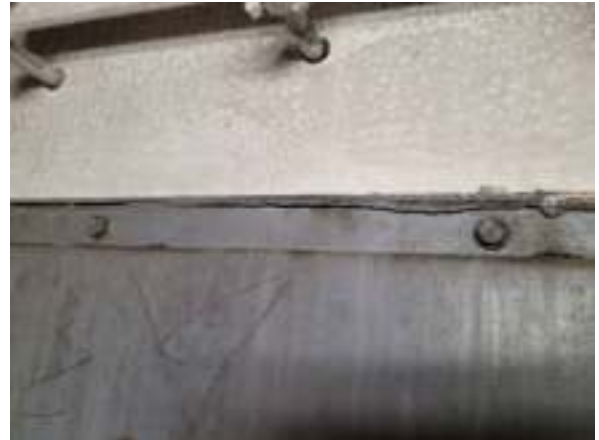
Photo #22 Asbestos-containing black seam caulk at AHU/Duct Joint (HA #16)

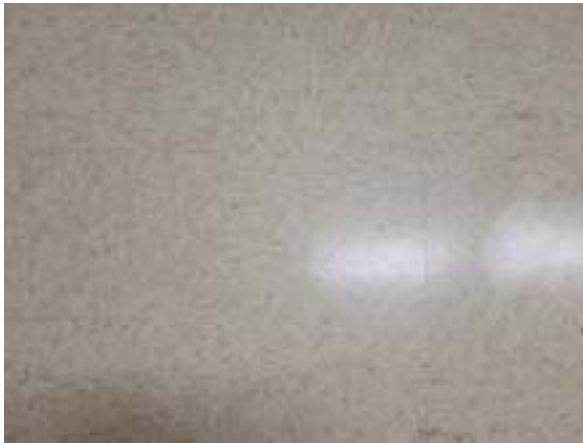
Photo #23 Asbestos-containing black floor mastic under non-asbestos containing 12" x 12" white with tan specks floor tile (HA #17)

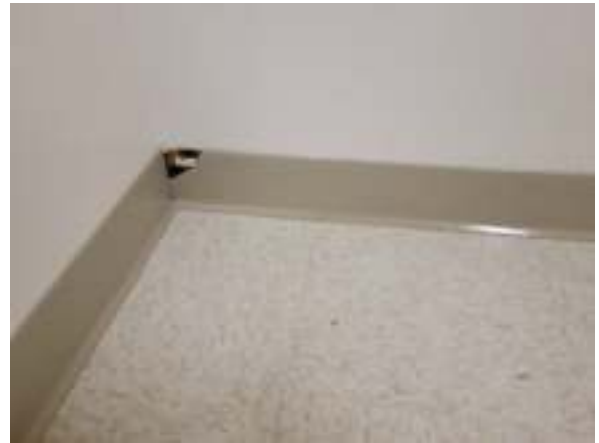
Photo #24 Non-asbestos containing 4" tan covebase and mastic (HA #18)

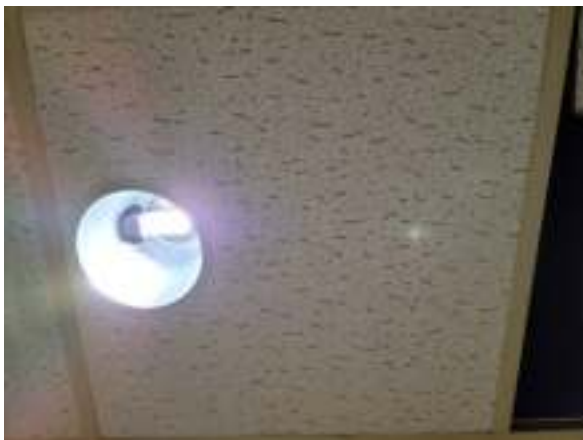
Photo #25 Non-asbestos containing 2' x 2' white ceiling tile with dots and fissures (HA #19)

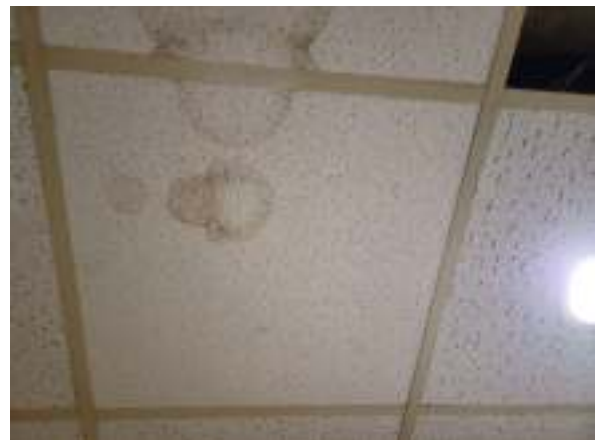
Photo #26 Non-asbestos containing 2' x 2' white ceiling tile with dots (HA #20)

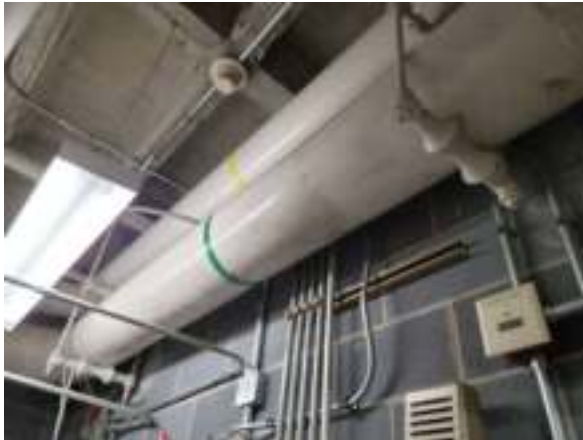
Photo #27 Non-asbestos containing white canvas wrap on 12"-14" pipes with asbestos-containing black mastic and OSHA-regulated (<1% asbestos) hard TSI elbows/joints (HA #21 and 22)

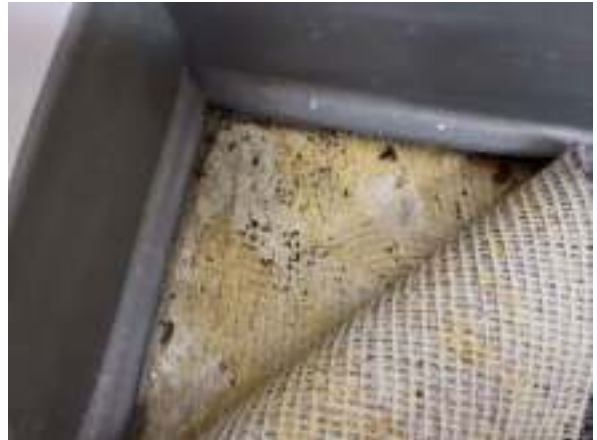
Photo #28 Non-asbestos containing tan carpet glue (HA #24)

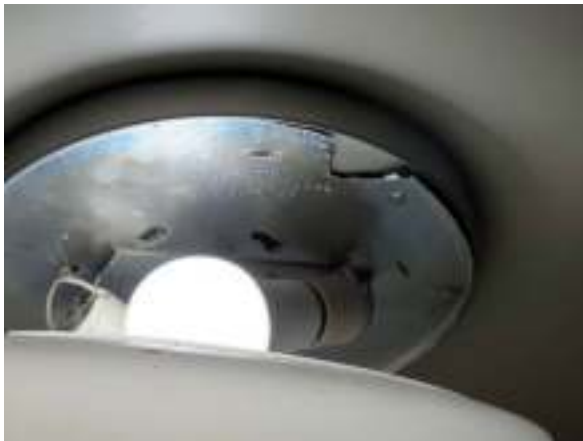
Photo #29 Asbestos-containing gray foil-backed light insulation (HA #25)

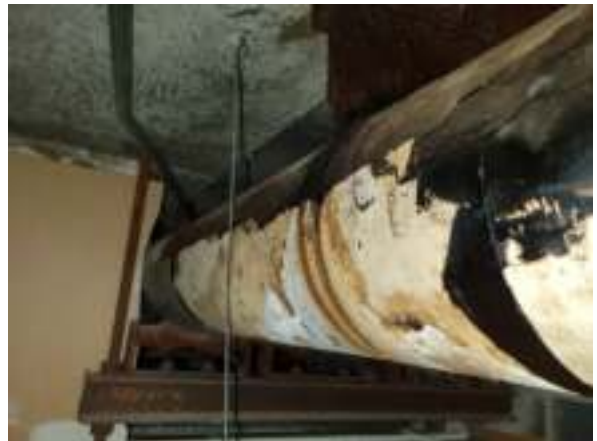
Photo #30 Asbestos-containing black mastic on fiberglass pipe insulation (HA #26)

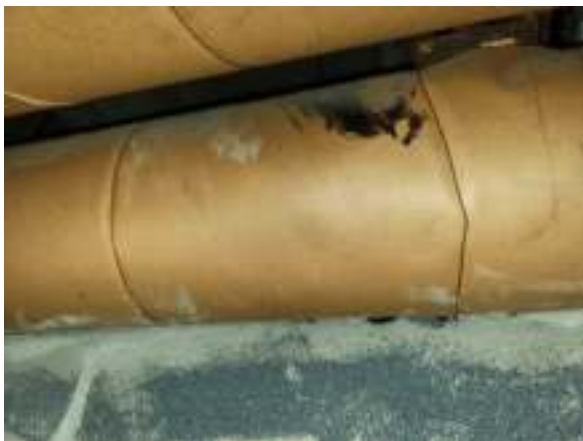
Photo #31 Non-asbestos containing brown paper and white canvas over fiberglass pipe insulation with asbestos-containing black mastic (HA #27)

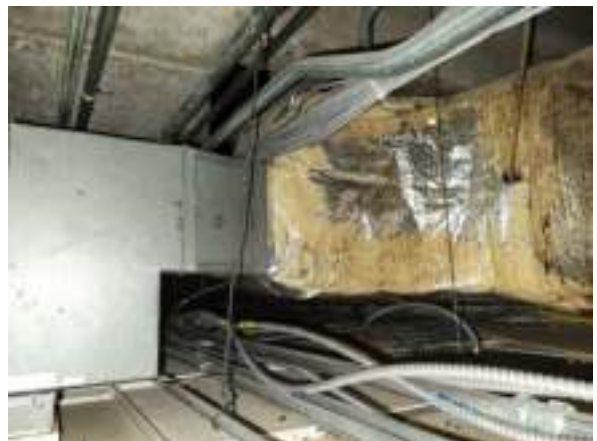
Photo #32 Non-asbestos containing yellow HVAC fiberglass duct insulation glue (HA #28)

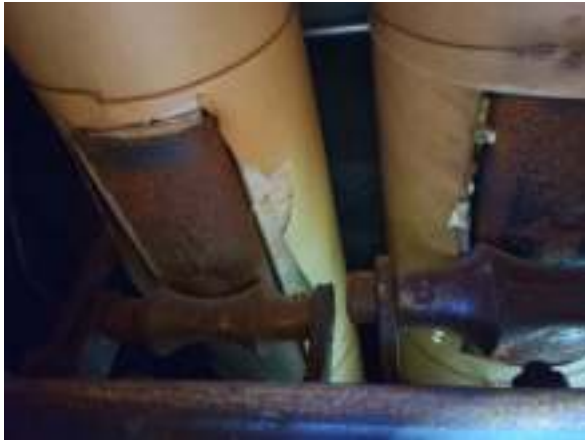
Photo #33 Non-asbestos containing brown paper over brown pipe insulation (HA #29)
